2C23 Profibus DP

Overview

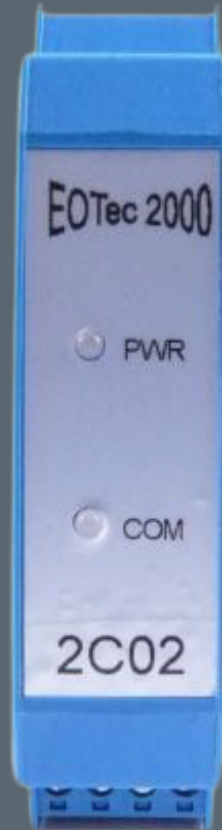
Electrical Interface Modules (EIM) connect the copper signal to digital signal for transmission over fiber via the Optical Interface Module (OIM). The basic modem configuration consists of a power supply, an EIM and an OIM. Additional modules may be added to configure daisy-chain, star and self-healing ring (SHR) topologies.
